COMPLAINT
(Jury Trial Demanded)

RE: Structural Evaluation of 351 Meeting St.
C&A Project No. 583867-17

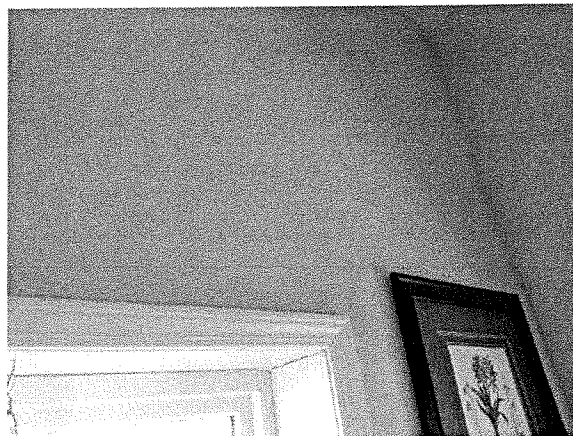
4 (before)

- 2 At the window on the front wall farthest to the left there was separation in the top left corner of the window molding and a hairline diagonal crack in the wall starting at this corner approximately 1' in length; above this same window an approximate 4' long and 1/8" wide horizontal crack was observed. This deficiency appeared between the December 4, 2017 and January 30, 2018 evaluations. All these cracks are getting wider and longer (see photos 4 and 5).

Due to the constraint of the surrounding structure, our previously recommended soil nail system into both walls in order to prevent any further settlement is not a viable option now. It is our opinion that the most efficient way to rectify the issue is to excavate the soil from inside the building and install steel beams vertically along the walls. The steel beams need to be epoxy bolted into the walls and secured at the top by the new poured concrete slab. During the excavation, all the existing interior walls need to be temporary shored to prevent collapsing and/or settlement. It is reported that there was a fuel tank abandoned underneath the building. Care should be exercised during the excavation to remove the fuel tank due to there may be hazardous material inside and around the tank. An environmental specialist shall be consulted to develop the procedure of removing the fuel tank. The entire building shall be vacated until the repair work is completely done. Only after both of these retaining walls are stabilized by the steel beam system should the above ground finishing repairs be made. This is a highly complicated repair project and finding a competent contractor could be a challenge. The contractor shall be required to have a Performance and Payment Bond to insure the proper repair work. The cost of performing the structural repair work only including A/E design is estimated at \$400,000.

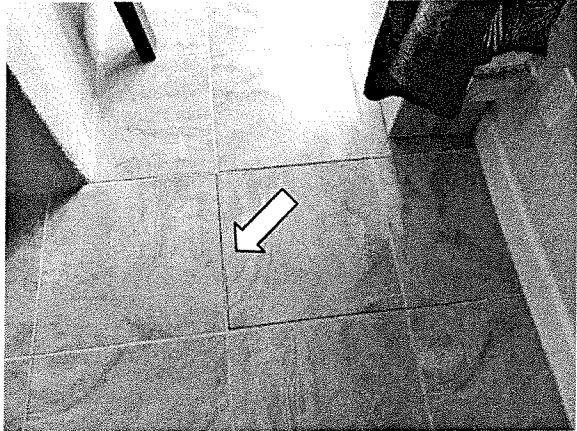
11

- 6 There is a new crack developed at the ceramic floor tile located at the rear right corner of the house (see photo 11).
- 7 On the exterior of the building at the window on the front wall nearest to the front left corner, multiple cracks were noted in the masonry veneer. The crack at the upper left corner of the window is getting wider (see photos 12 - 14).

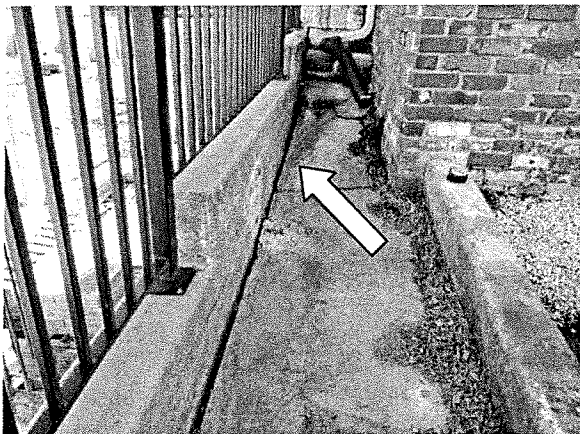
15 (before)

- 8 A separation was noted along the right face of the concrete retaining wall and the concrete curb/concrete splash pad. The maximum separation at the concrete curb was measured to be approximately 1-3/4" wide. This separation is getting wider (see photos 15 - 16). There is a new stair step crack developed at the lower portion of the left wall window (see photo 17).
